Safety Enhancement and Strengthening of Les Toules Arch Dam

O. Müller¹ and **A.** Wohnlich¹

¹STUCKY S.A., Rue du Lac 33, Case postale, CH-1020 Renens VD, Switzerland

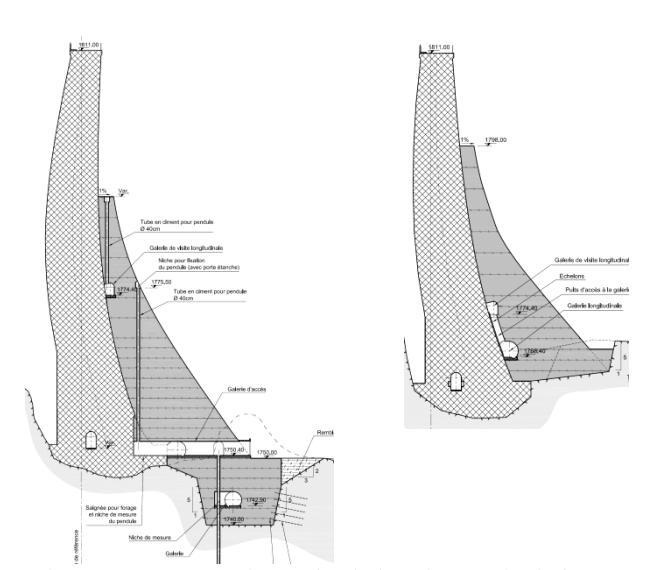
Figure 3: Cross-sections of existing dam and reinforcement; Left: Bloc 6, 10 m local deepening into the foundation; Right: Typical cross-section

Locally in the area of blocs 5, 6 and 7 (left bank), where the weakest geological layer prevails (mica schist rock), the dam abutment stability analysis of the existing dam revealed that the dam foundation was too shallow and not sufficiently deeply founded into the rock mass [3]. To comply with the design requirements, a 10 m deepening of the dam foundation was designed (Figure 3, left), bridging the weak mica schist layer between both stronger, neighbour gneiss layers.

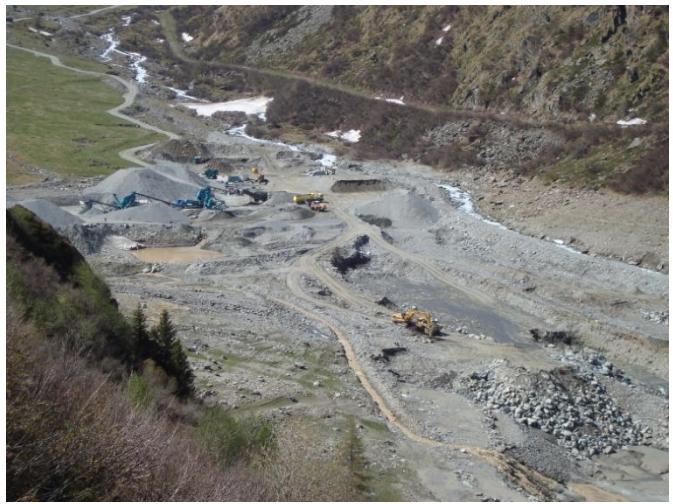
Taking advantage of the operating constraints during the strengthening works as mentioned above, the quarry is located between 1780 and 1810 m.a.s.l. in the reservoir bed, upstream of the dam at the river mouth, as shown in Figure 4 below. The aggregates and sand necessary to produce the dam concrete are sourced from this quarry.

Figure 4: Quarrying inside the reservoir lowered during construction works

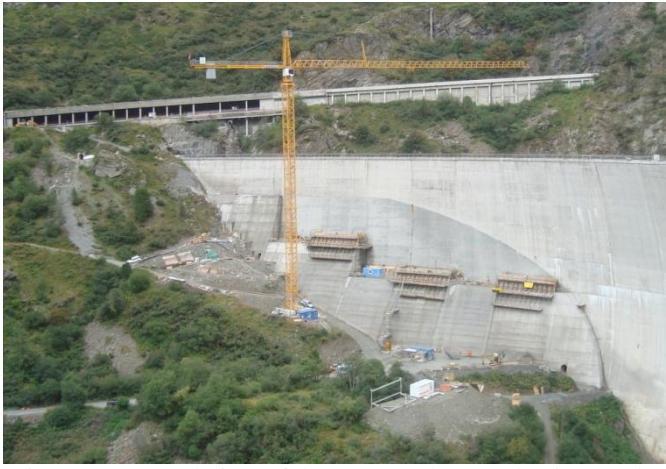
Considering that the crane is able to operate between 12 and 15 rotations/h and with respect to a 40 m³/h concrete placement rate to be ensured, the capacity of the bucket shall be 3 m³. The load of the full bucket (10 tons), together with the location of the crane and the abutment thickening size lead to a crane capacity of 630 tons meters. The crane is 95 m high and is shown in Figure 5.

Figure 5: General view of the crane and strengthening work in the right bank (2009)

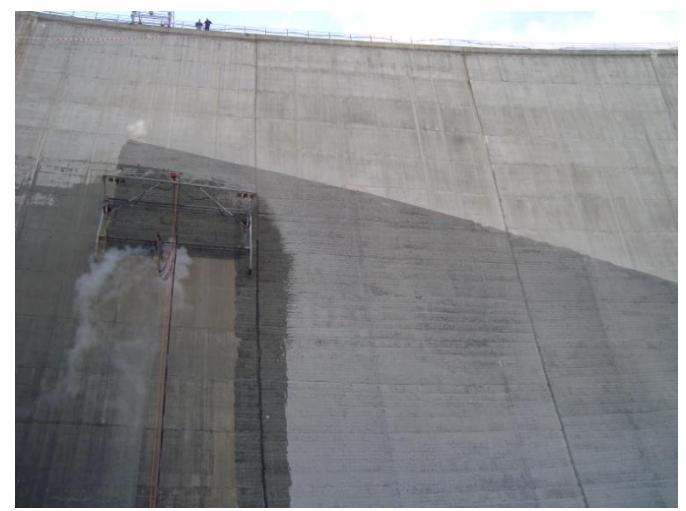
Bounding between existing dam and abutment thickening The bounding between the existing dam and the strengthening was performed by a proper hydrodemolition with high pressure rotating water jets (2500 bars) and with diameter 25 mm steel anchor bars grouted into the existing dam. The density of the steel anchors is 4 pieces/m² in a 3 m wide belt in the edge of the contact surface, and 1 piece/m² anywhere else. Hydrodemolition was carried out using an automatic mobile gantry as shown in Figure 6 below and allowed an average surface roughness of 2 cm.

Figure 6: Hydrodemolition as a means to prepare the interface surface between old and new concrete

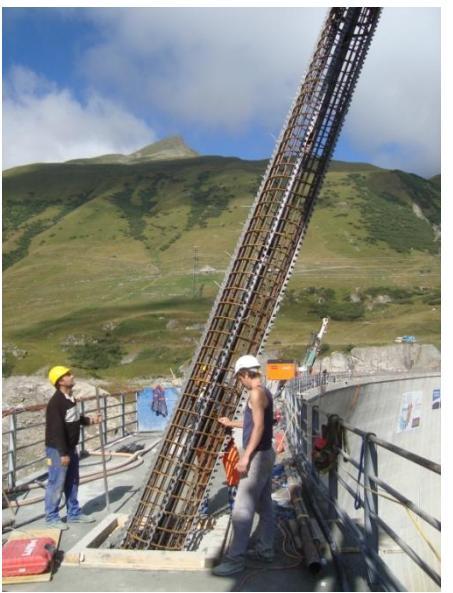
Drilling of the 16 m deep shear columns with a 700 mm diameter required the implementation of a specific, 3 steps methodology. First, 120 mm diameter core drilling was carried out; then boring out with 400 mm diameter; and finally, reaming with a 700 mm diameter, rotative diamond tricone.

Together with the 120 mm core drilling, deviation checking was performed to ensure that the drilled column effectively was aligned with the dam contraction joint. Then, reinforcement was placed and self compacting concrete was poured from the bottom of the hole in an ascending stage.

Figure 7: Placing of reinforcing cage after drilling of 700 mm column and before self compacting concrete pouring

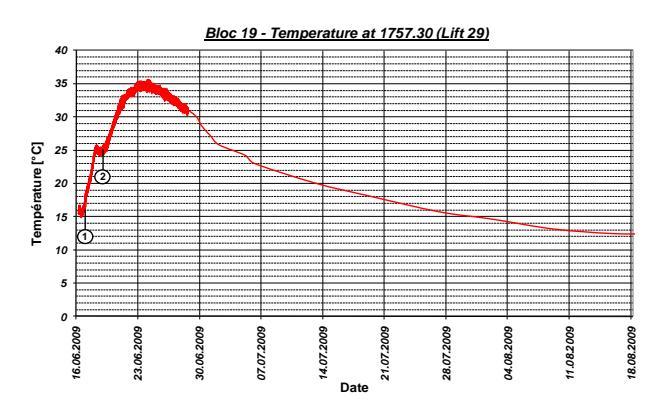
Figure 8: Concrete temperature vs. time curve showing temperature rise caused by cement hydration heat and subsequent effect of post-cooling

Indication 1 on the graph corresponds to the beginning of concrete placement, whereas indication 2 shows the thermal effect of placing the next, upper concrete lift (after 3 days). The average temperature rise reached 22°C, which means

that a maximal fresh concrete temperature of 13° C was allowed in order to meet the requirements. During summer, when fresh concrete temperature was too high and caused the exceeding of the maximal authorized peak temperature (35° C), additional cooling pipes were placed, thus reducing to 1.5 m the spacing between two successive post-cooling layers.

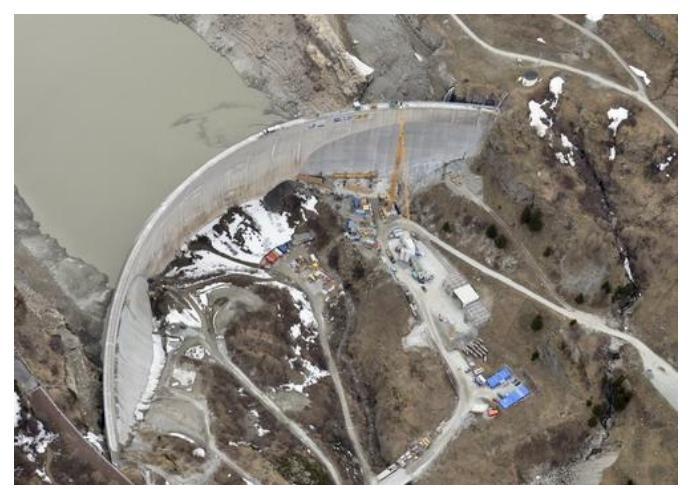
Figure 9: Aerial view of the dam during strengthening works
