Open air excavations at Deriner dam

Olivier Muller provides details on the excavation works carried out as part of the Deriner arch dam project on Turkey's Coruh River

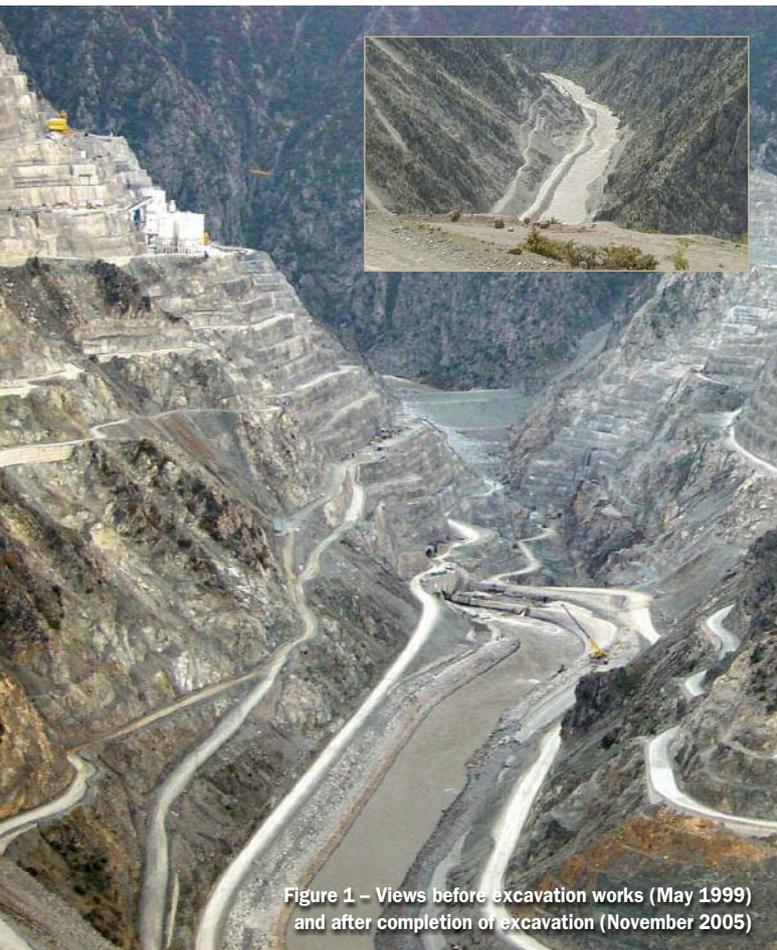
Figure 1 – Views before excavation works (May 1999) and after completion of excavation (November 2005)

Excavation began in October 2000 on the Left Bank. In August 2005, all open air excavations for the dam foundation were completed. The total volume of excavated material amounts to 8.7Mm³. Figure 1 shows the project site before and after excavation.

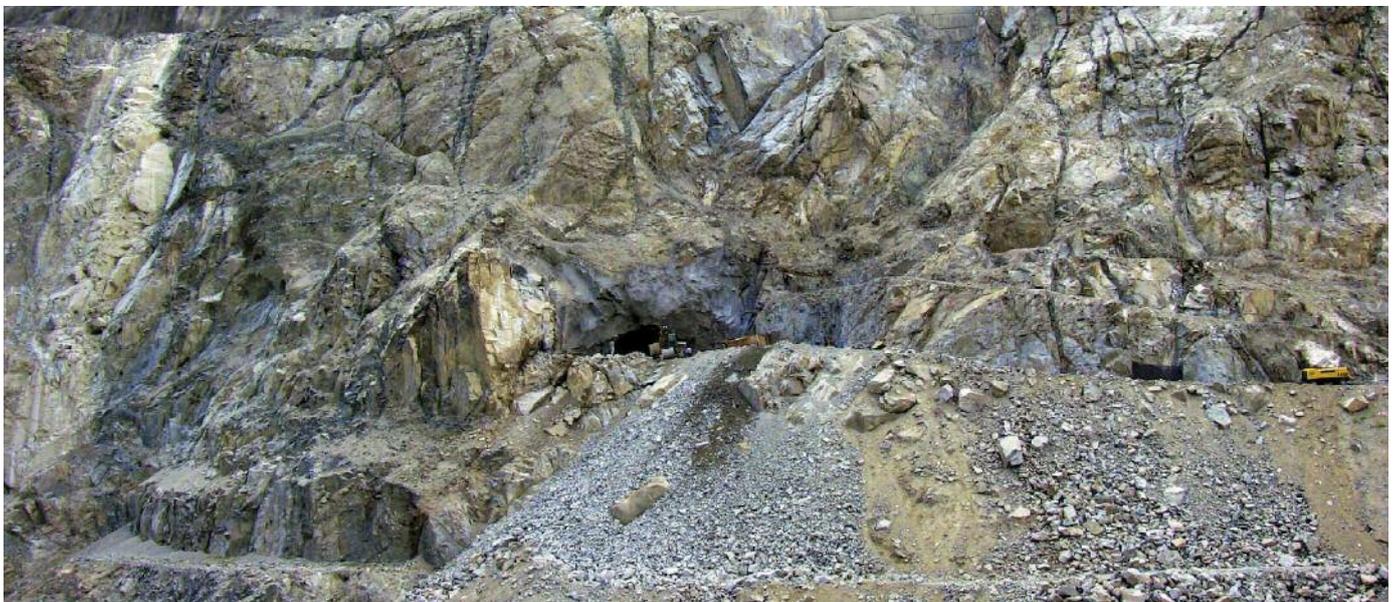
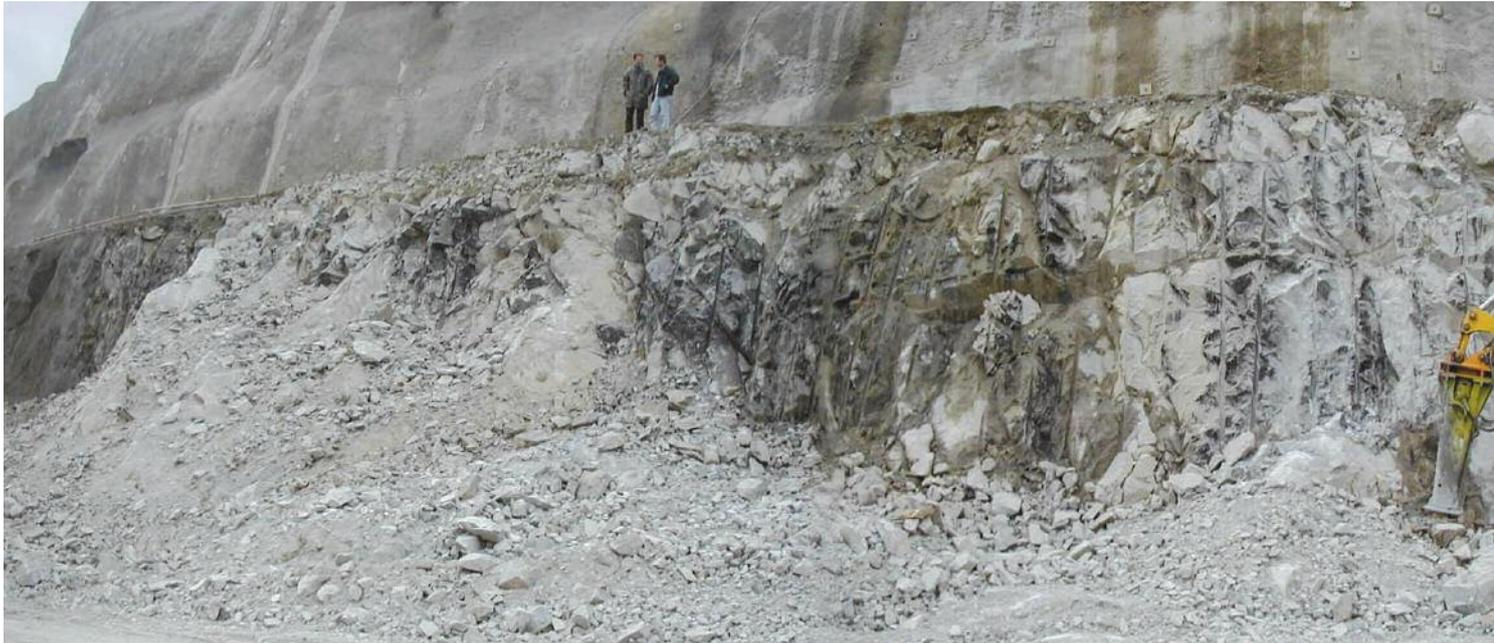
Right: Figure 4 – Right bank – failures assumptions for global stability analysis during excavation;

Figure 4 represents an example of a global stability analysis considering failure within the rock mass and failure along joints C.

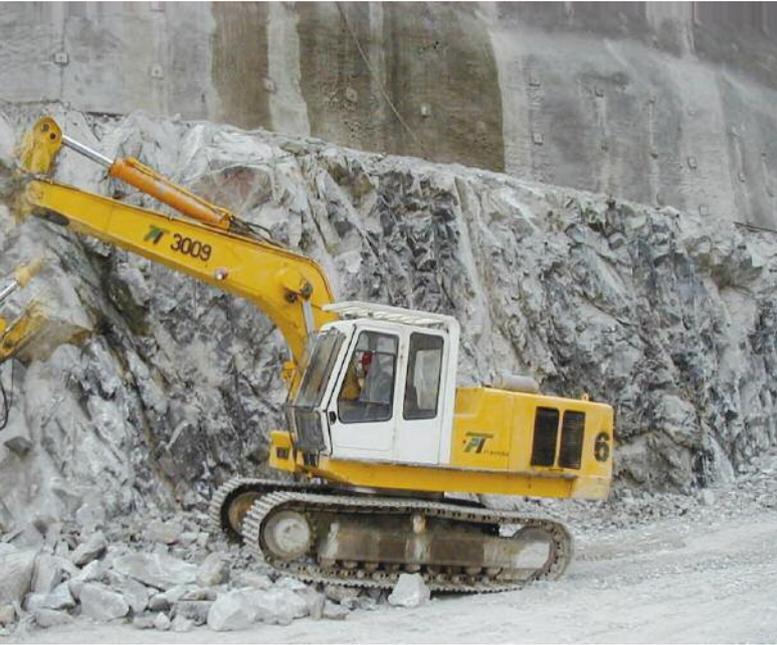
Above: Figure 5 – Excavation at the Right Bank at chainage 310m between elevations 420 and 427m asl

Drilling and blasting using the pre-splitting method has been undertaken at the Deriner site for the majority of the excavations since the start of the works. However, the first sections of the dam foundation were excavated using a different method – a controlled blasting method which, as applied on site, has been observed to yield less favourable results. Pre-splitting on the dam foundation below el. 297m on the Left Bank and el. 342m on the Right Bank showed improvements in the excavation method. Figure 5 shows the rock surface of half a berm just after blasting.

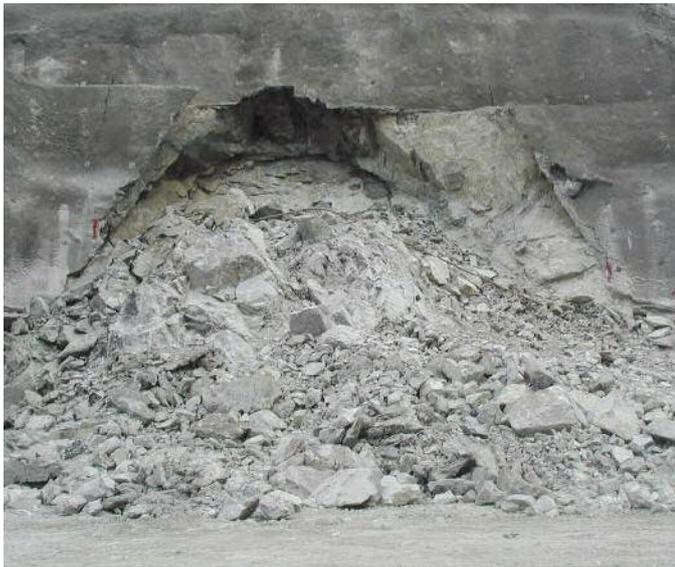
**Left: Fig 8 – Landslide from 2 September 2002 with 300-400m³ of rock.
Right: Fig 9 – Monitoring of the left bank between elevations 451 and 620m asl**

The design methodology for the slopes stability has been conducted in a safe and economical way. An over-conservative design would have resulted in more anchors installed, from which some would have been ineffective. It has to be pointed out that no major incident or large-scale instabilities have occurred within the whole dam excavation area. Some small rock slides occurred, but without any personal or material damage. For example, on 2 September 2002, a rock portion of some 300–400m³ failed and broke out of the excavated berm at 357–372m asl on the Right Bank excavation, upstream of the dam at approximate chainage 140m, as illustrated in Figure 8.

This critical area is directly above the Power Intake Structure and is also within 20m of the Right Bank Overflow Spillway at that elevation. The rock slide cracked the foundations of the cable crane loading quay at the southern end. Based on the location and the geometry of the slide, it appears that sliding occurred on the C-joints, which had already been identified as the less

favourable joints. This has been the most notable incident that has occurred during excavation, and is generally expected on projects of this scale.
